EFFECTS OF THE LOMA PRIETA EARTHQUAKE  
ON THE MARINA DISTRICT  
SAN FRANCISCO, CALIFORNIA

OPEN-FILE REPORT 90-253

Menlo Park, California

April 20, 1990

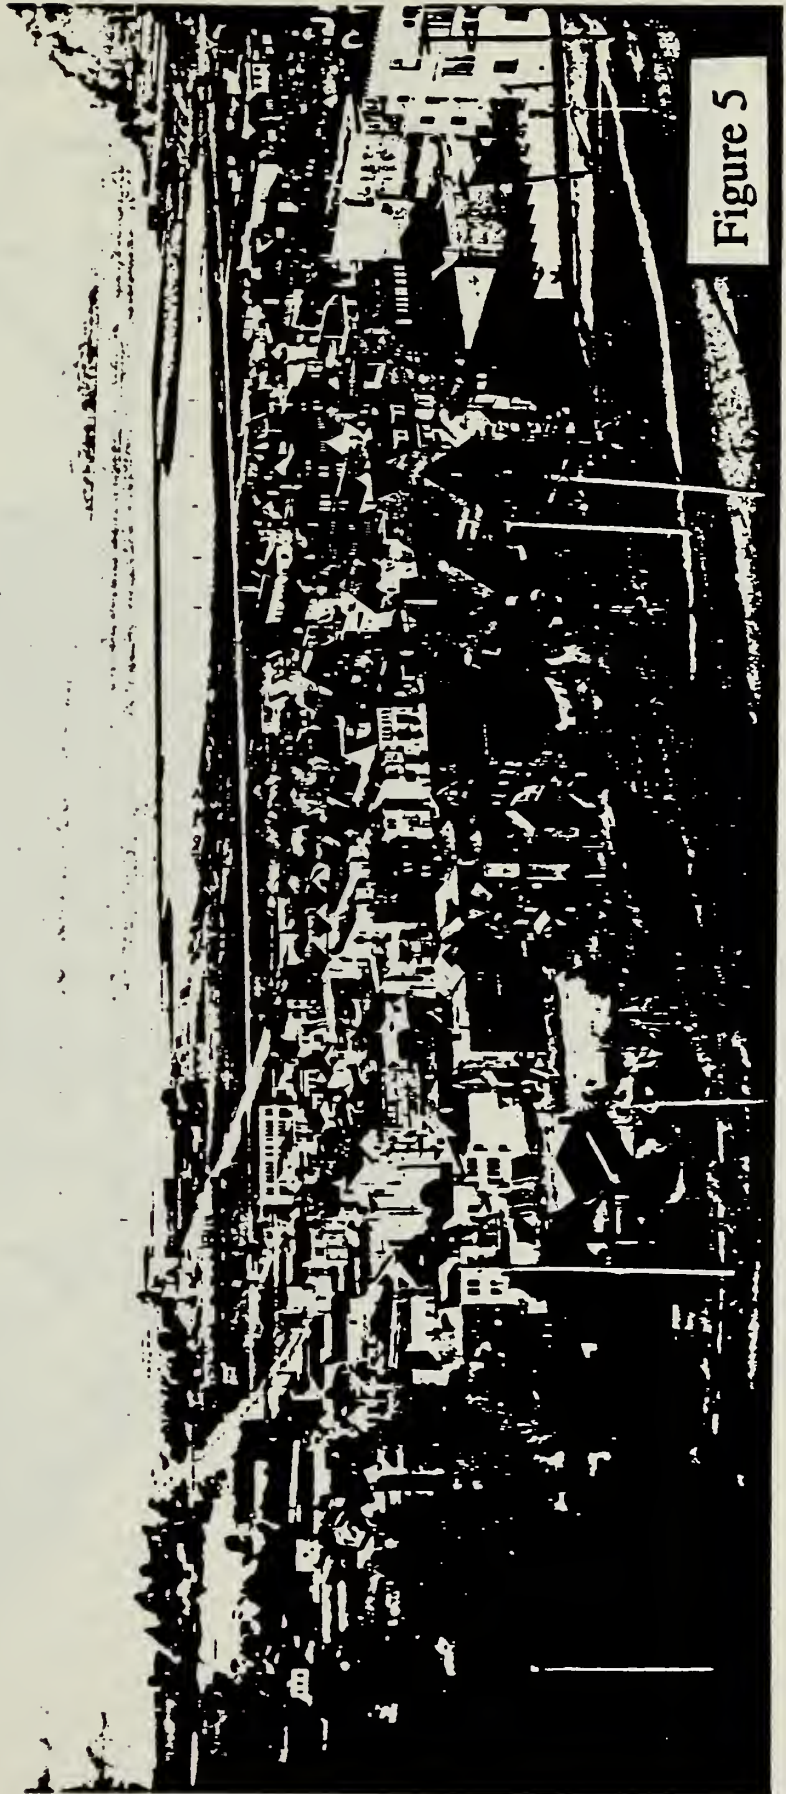
Figure 5

Figure 5. Photograph of the Marina area taken in April (?) 1912. The cove that was filled for the Panama-Pacific International Exposition is in the right middle ground. Piling from the angled pier shown on the 1895 map (figure 3) is in the lower right side of the cove. The pond in the left part of the photo is now part of the lagoon at the Palace of Fine Arts. Next to the pond is Baker Street, and then Broderick Street. Photo courtesy of Archives, San Francisco Main Library.

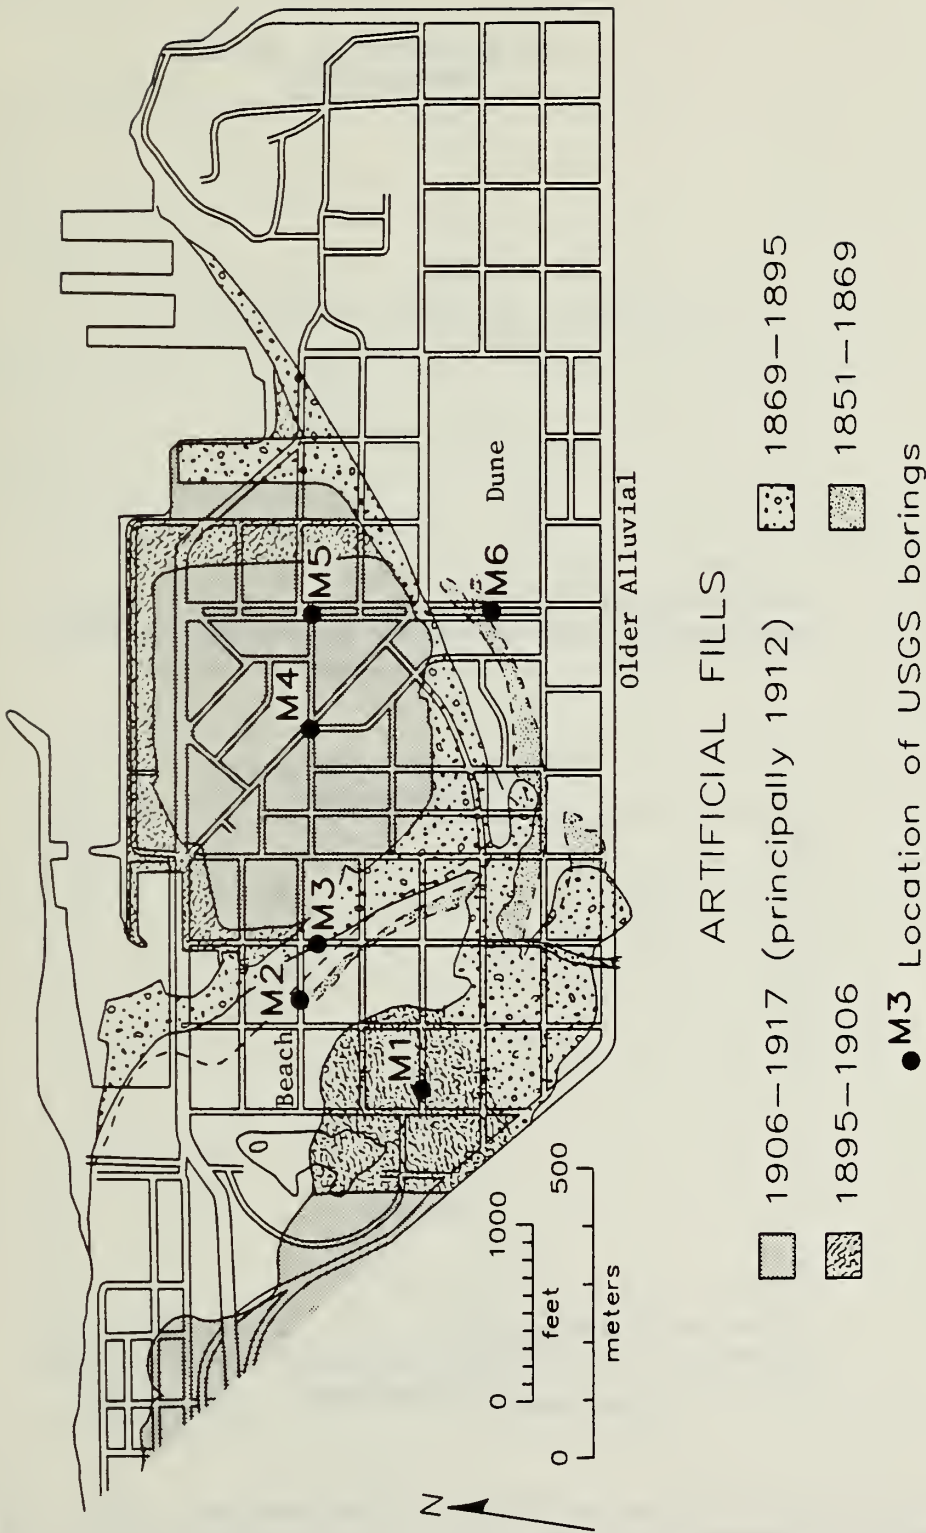
Figure 1. Map shows the general locations of the geologic units (the older alluvial deposits are generally south of Lombard St) and the location of the different fills used to reclaim the Marina district. The central fill area is referred to as Marina Cove.

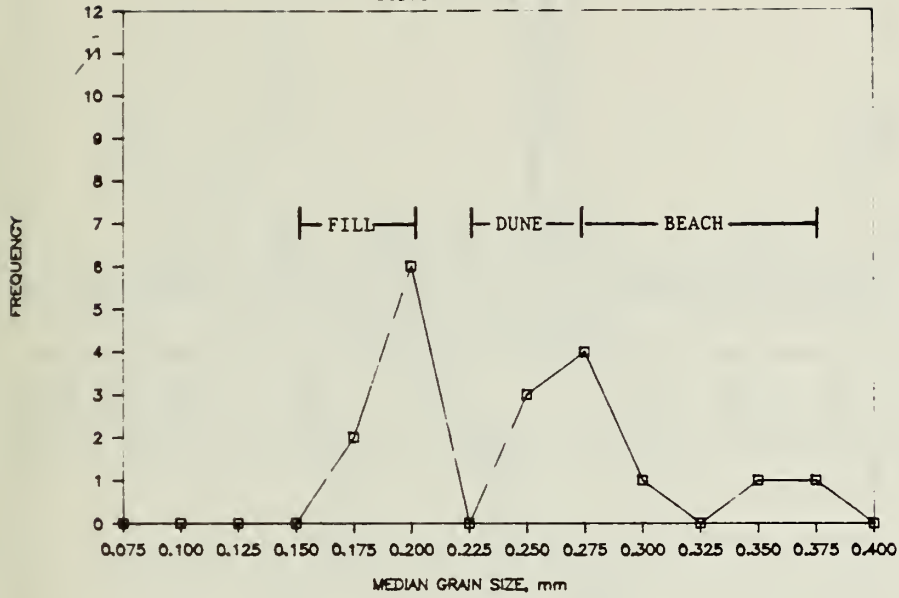
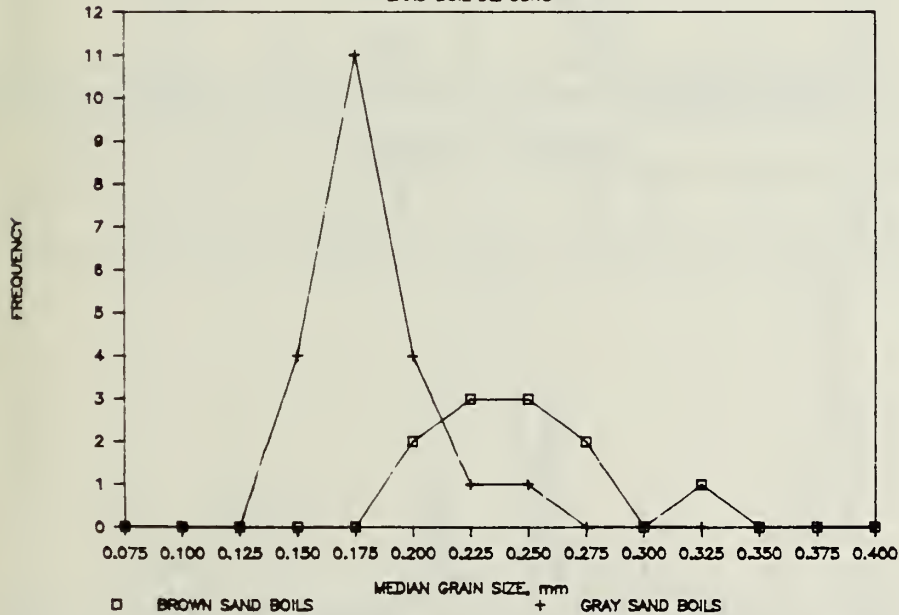
Figure 2A. Grain size frequency of subsurface units. In 2A the peak at 0.200 mm indicates that 6 samples have median grain sizes between 0.175 mm and 0.200 mm. The median grain sizes of the different subsurface units generally do not overlap. 2B. Grain size frequency of sand boils. Gray sand boils have a finer median grain size than the brown sand boils.

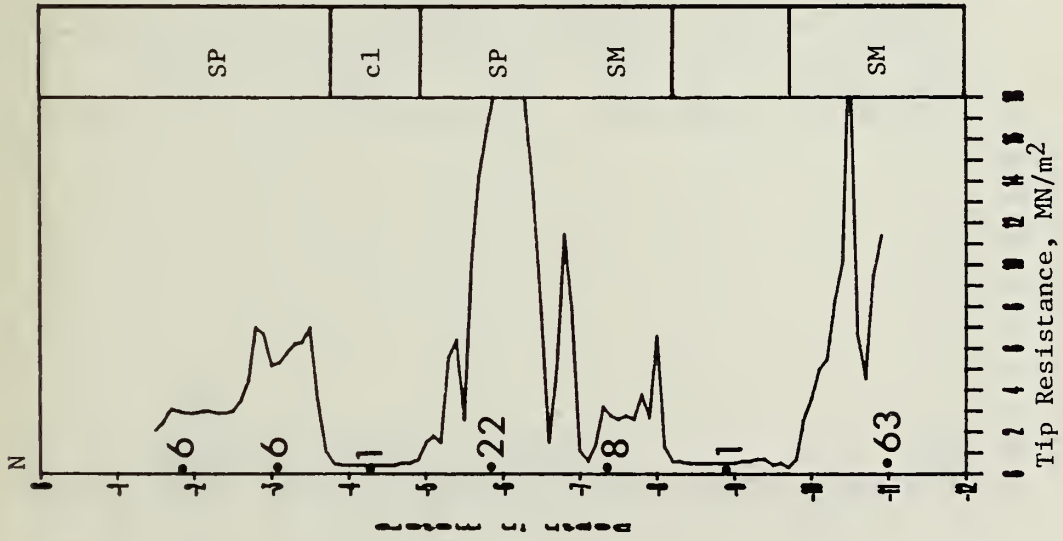
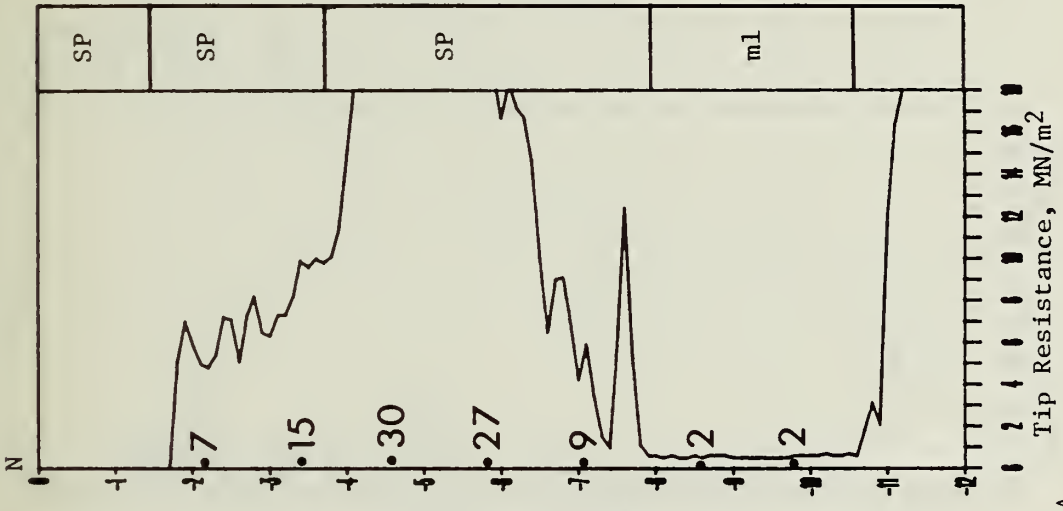
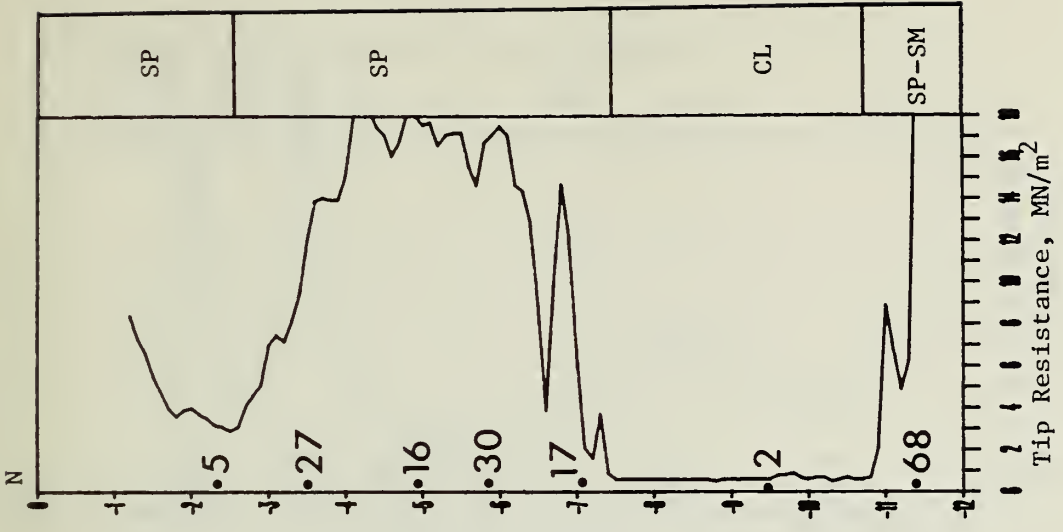
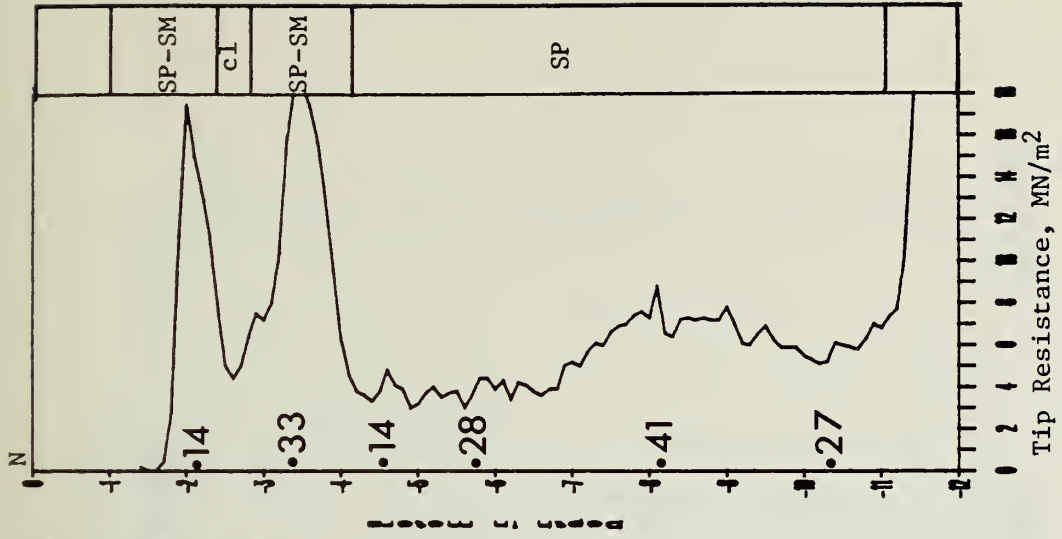
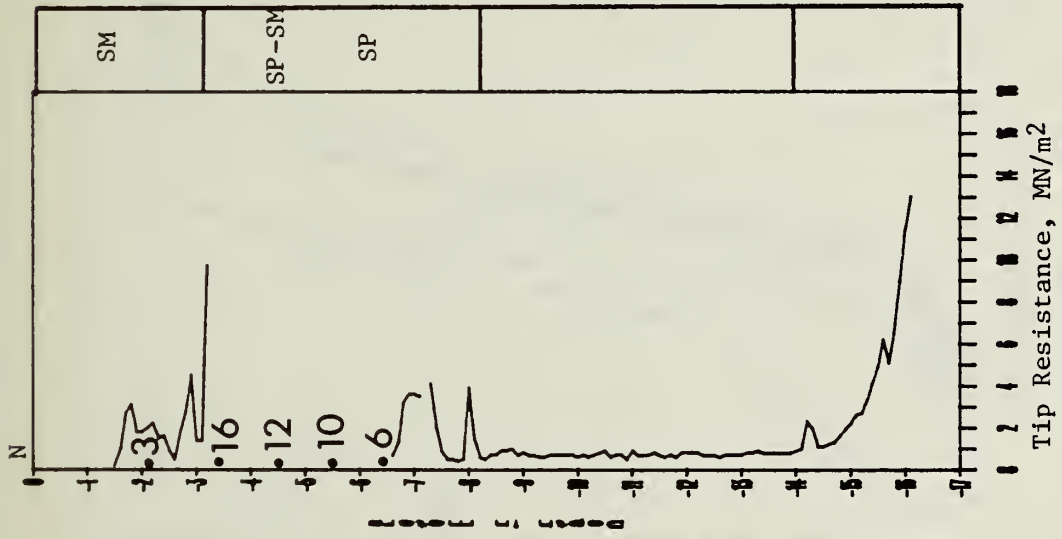
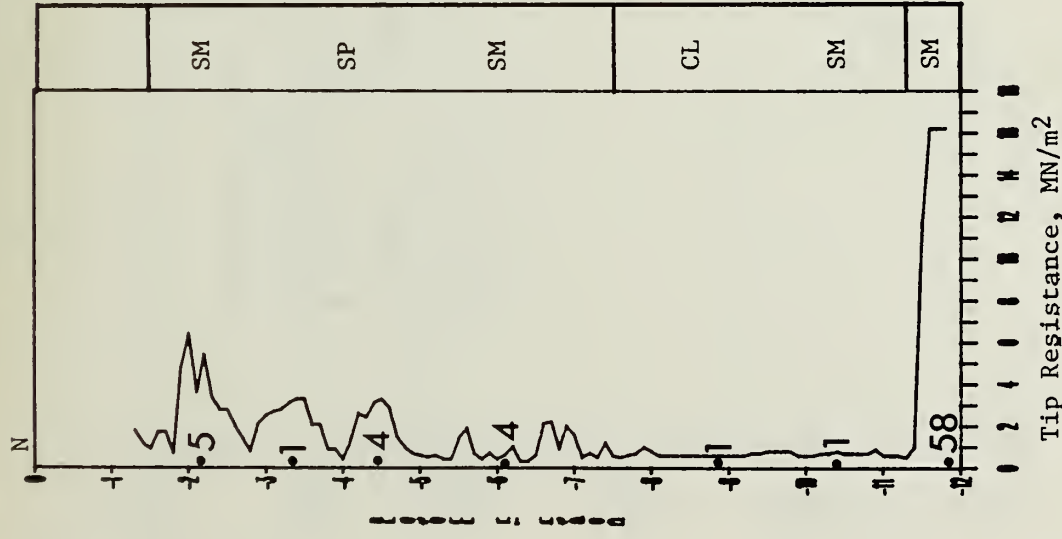
Figure 3A and 3B. Soil profiles defined by the cone penetration test. Blow counts (N) are uncorrected. Lower case classification symbols indicate uncertainty in the designation. Depth is in meters. Note change in vertical scale for CPT 5.

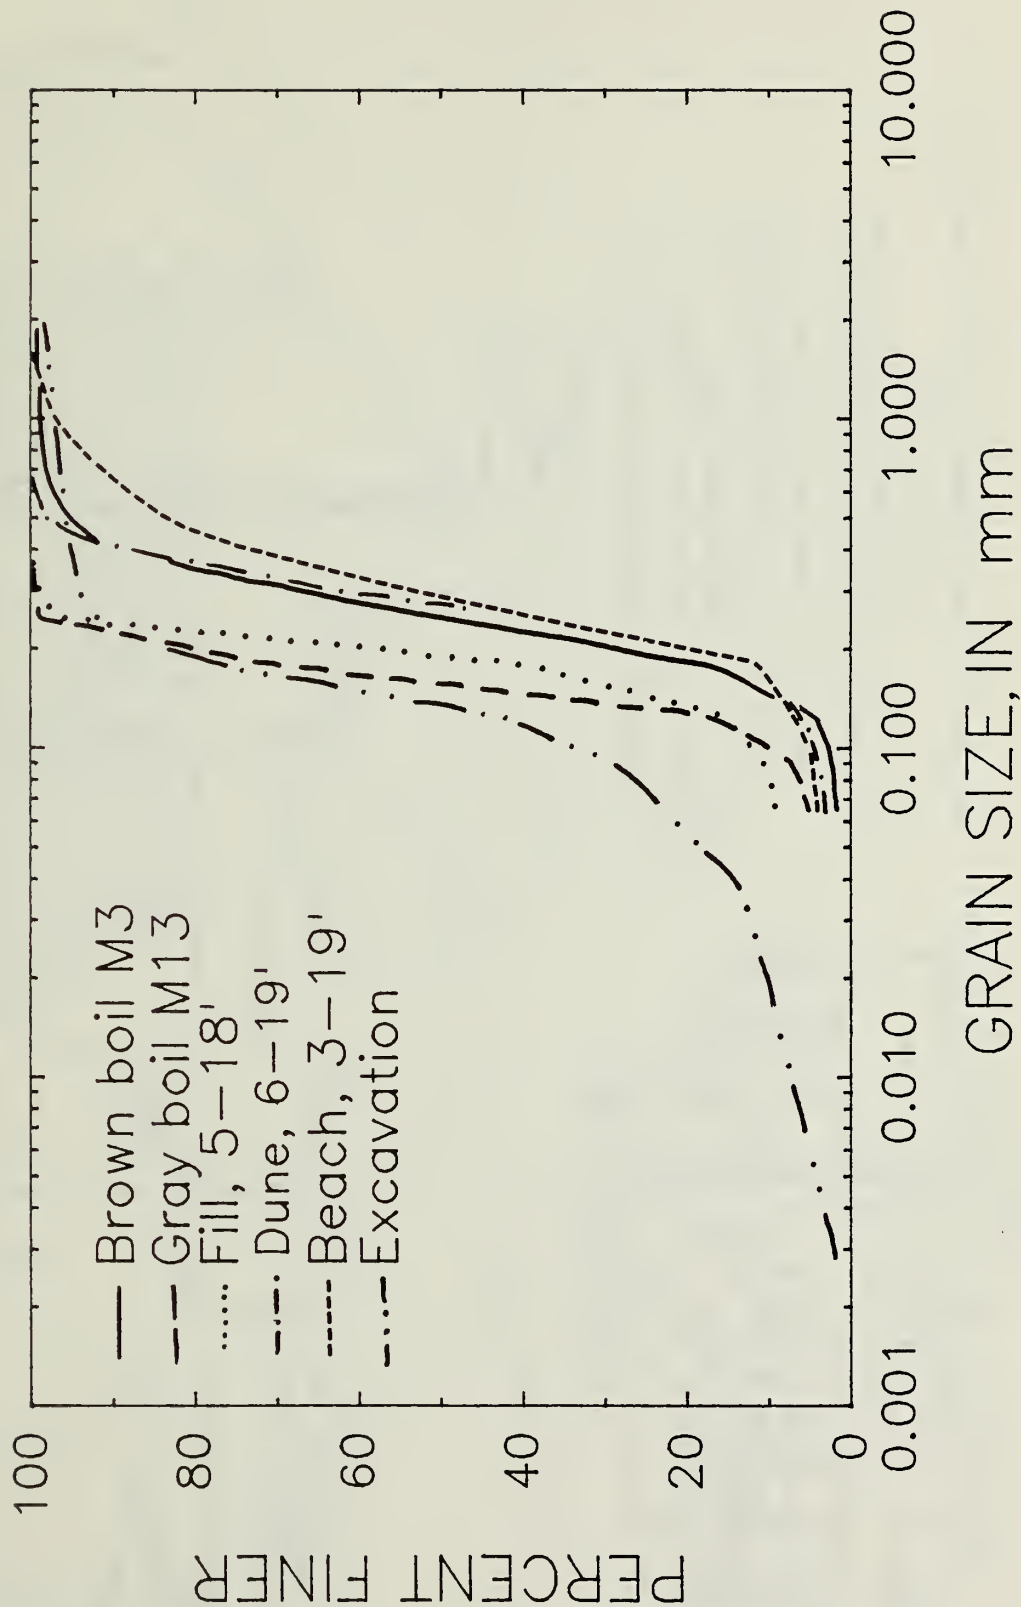
Figure 4. Grain size curves for subsurface and sand boil samples.

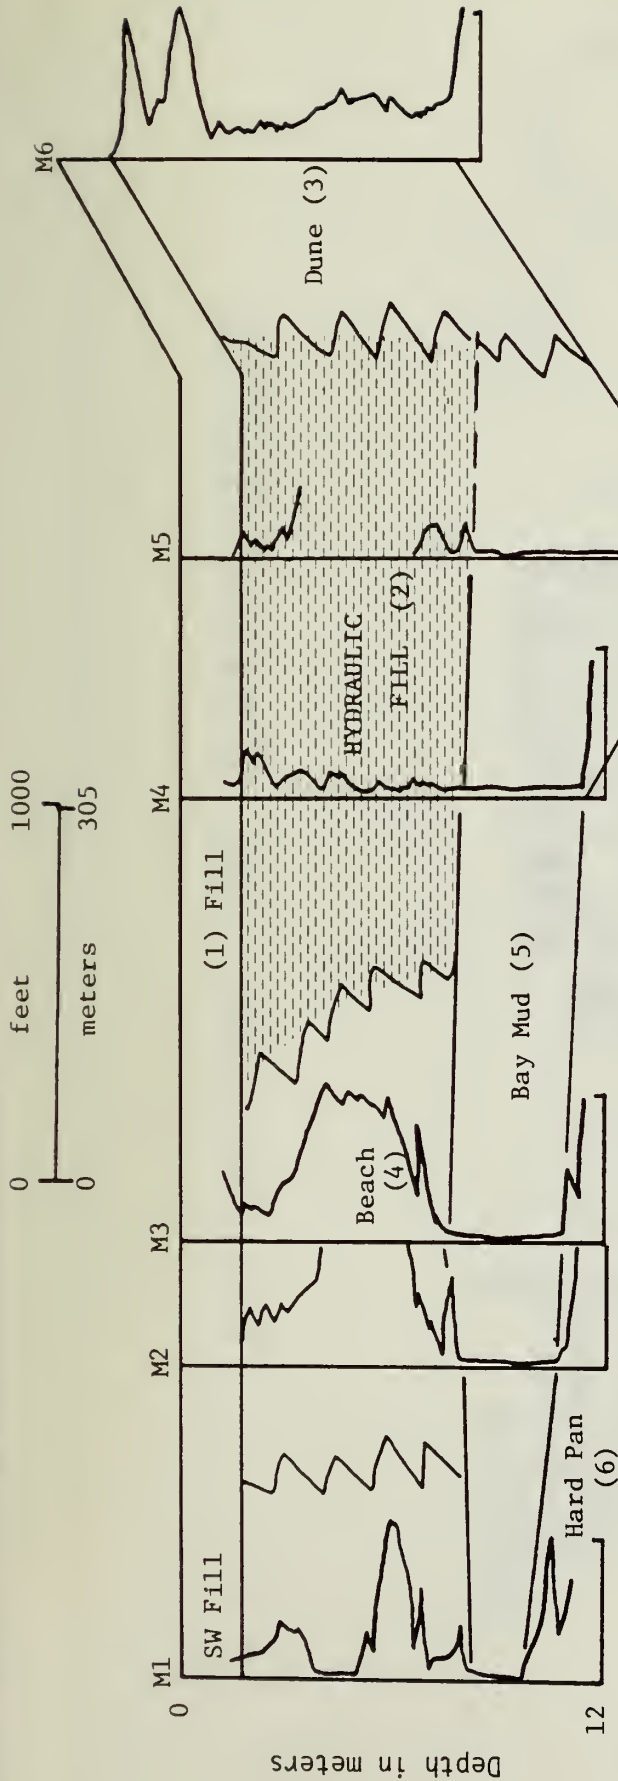
Figure 5. Generalized cross section based on the cone penetration tests. The profile line is not straight. Note the contrast in tip resistance between the hydraulic fill (unit 2), beach deposit (unit 4), and dune deposit (unit 3).

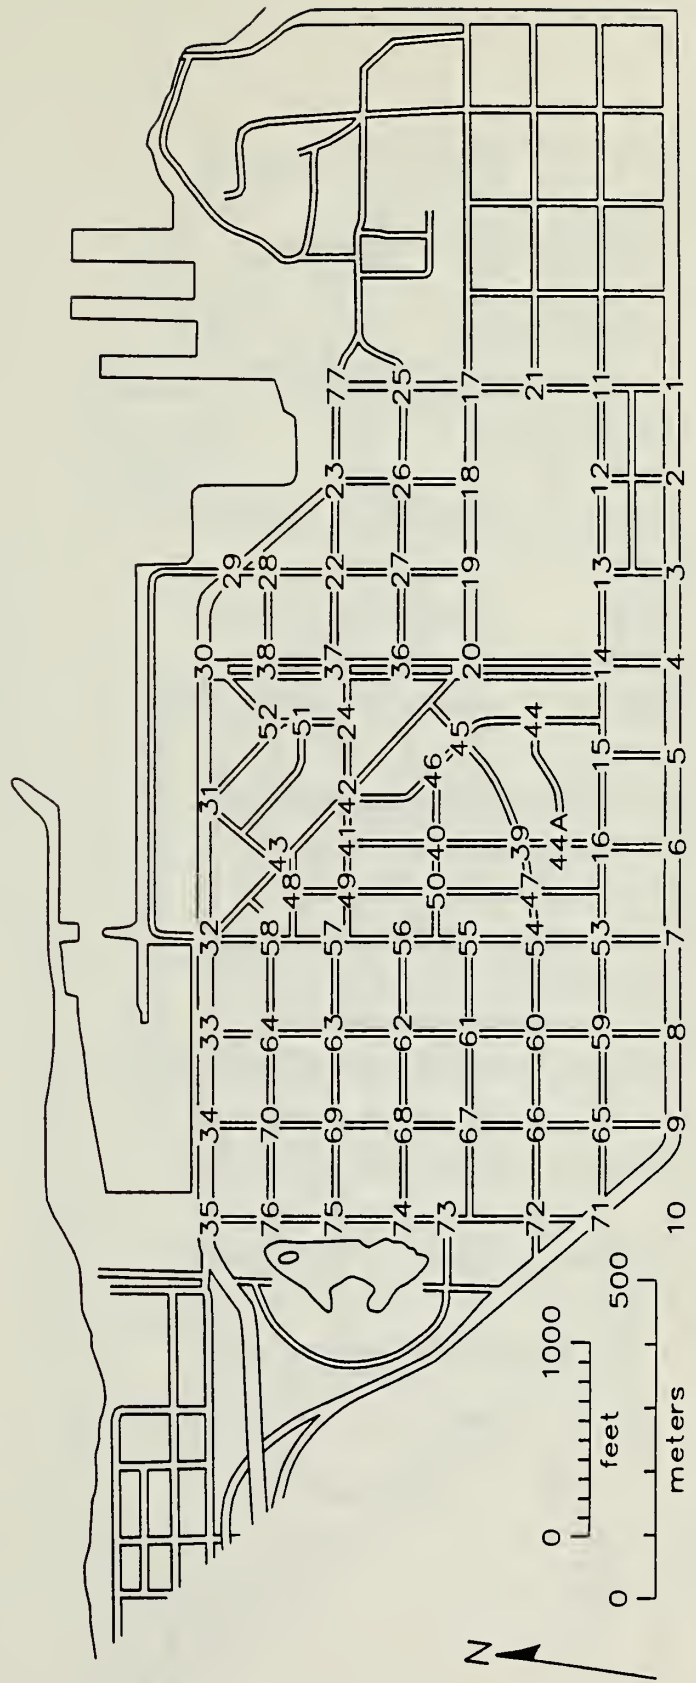
Figure 9. Location of survey stations. A description of settlement at the stations is given in Appendix C.

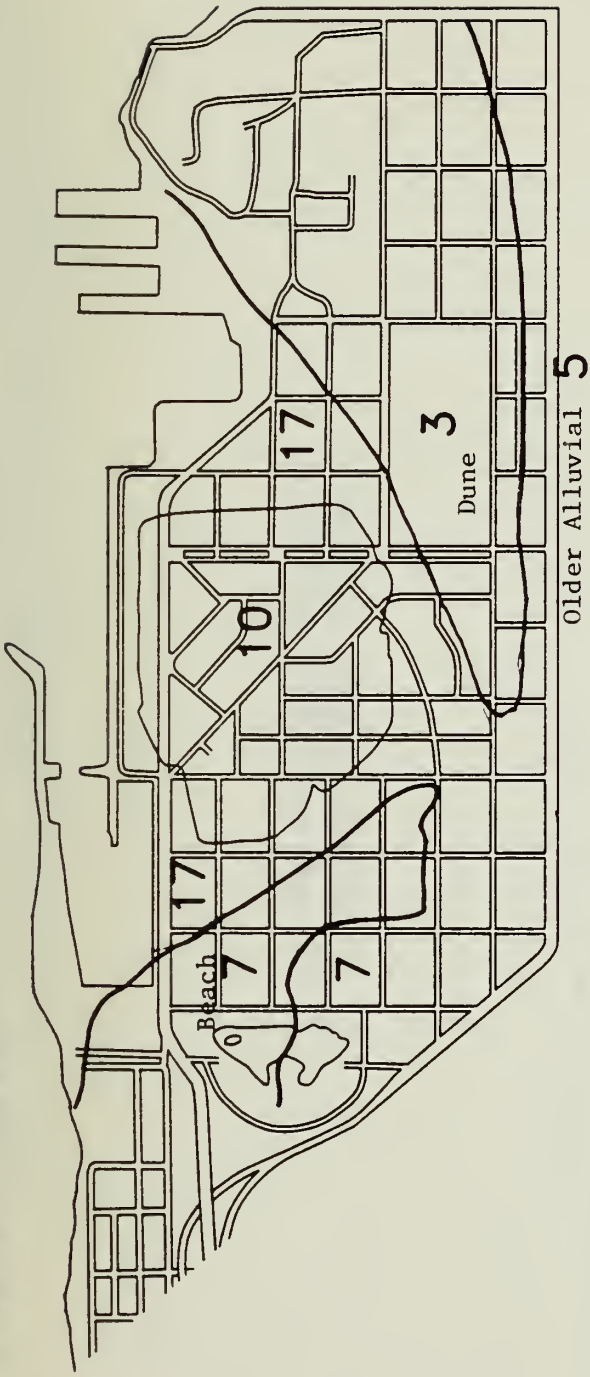
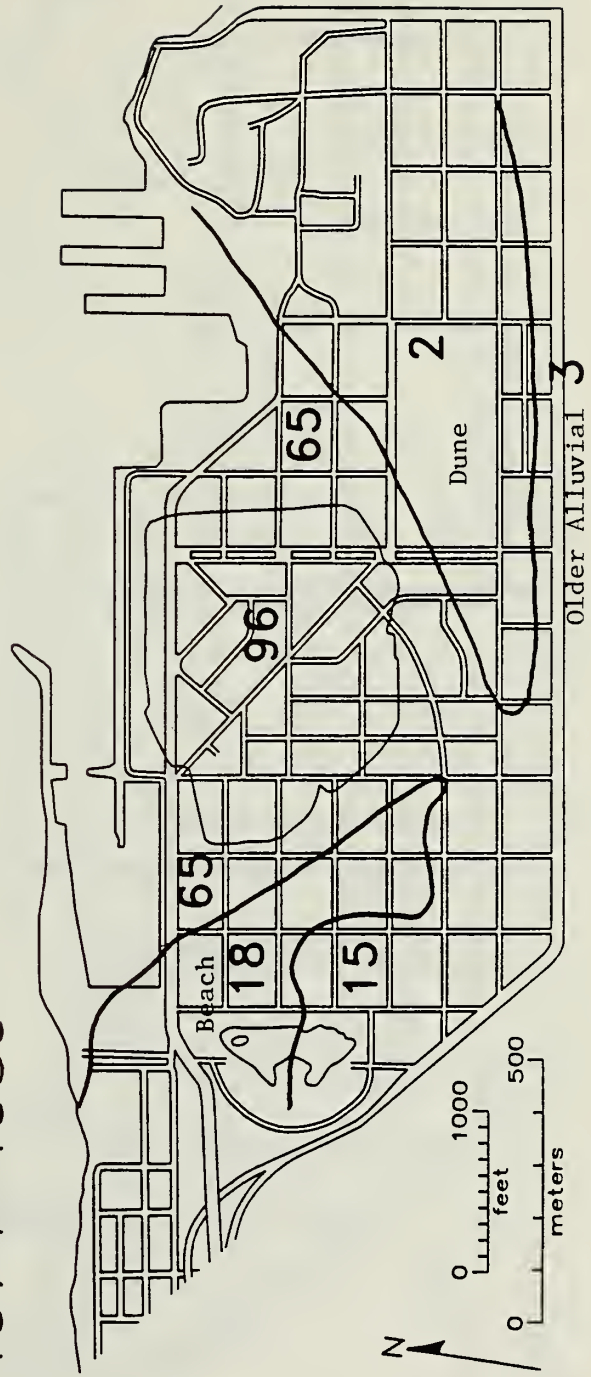
Magnitudes of settlement within the district correlate well with the geologic units (fig. 11). The average settlement for the different deposits before and after 1974 is shown in figure 11. The ratio between settlement in 1974-1989 and 1961-1974 is shown in figure 12 and Table 3. The natural deposits (dune, beach, and older alluvium) typically settled between 3 and 7 mm prior to 1974. After 1974 the range in average settlement of the natural deposits was 2 to 18 mm. In terms of settlement the fill is divided into three groups; a central fill (1869-1895), a southwestern fill (1895-1906), and the post-1906 Marina Cove fill. Except for the dune and older alluvial deposits all units showed greater settlement in the period 1974-1989 than the period 1961-1974. The difference as shown by the ratio of post 1974 settlement to pre 1974 settlement indicates that the increase of settlement was not uniform. The post-1906 fill showed almost 9 times more settlement after 1974 than before 1974 whereas the western fill showed less than twice as much settlement. Profiles along Divisadero (fig. 13) and Beach Streets (fig. 14) show that different magnitudes of settlement are associated with different geologic units. The hydraulic fill of the Marina cove is associated with the greatest magnitude of settlement.

Figure 11. Average Settlement between the years 1961-1974 and 1974-1989.

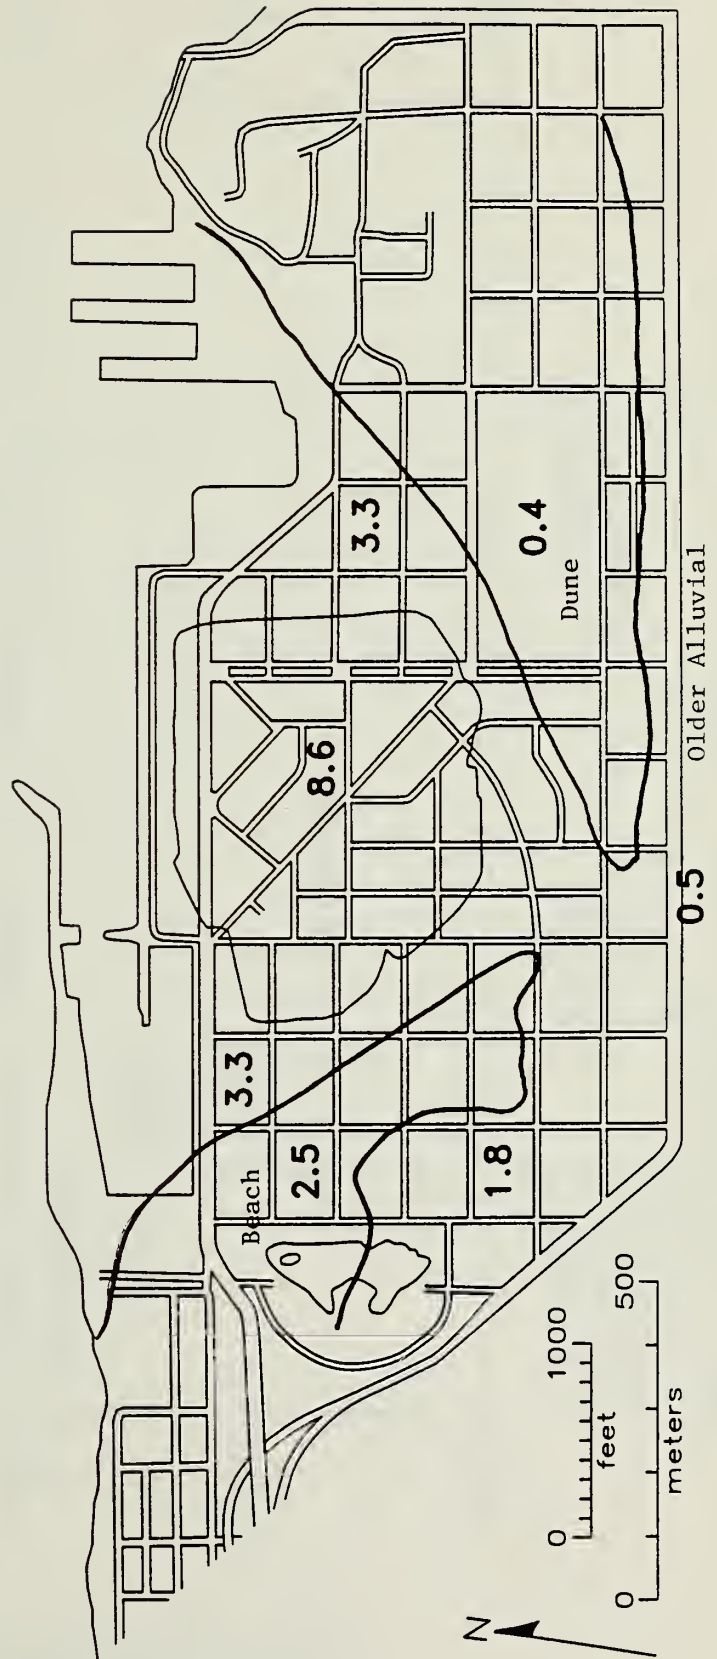
Figure 12. Ratio of 1974-1989 settlement to 1961-1974 settlement. Ratios less than one indicate more settlement took place before 1974 than after 1974.

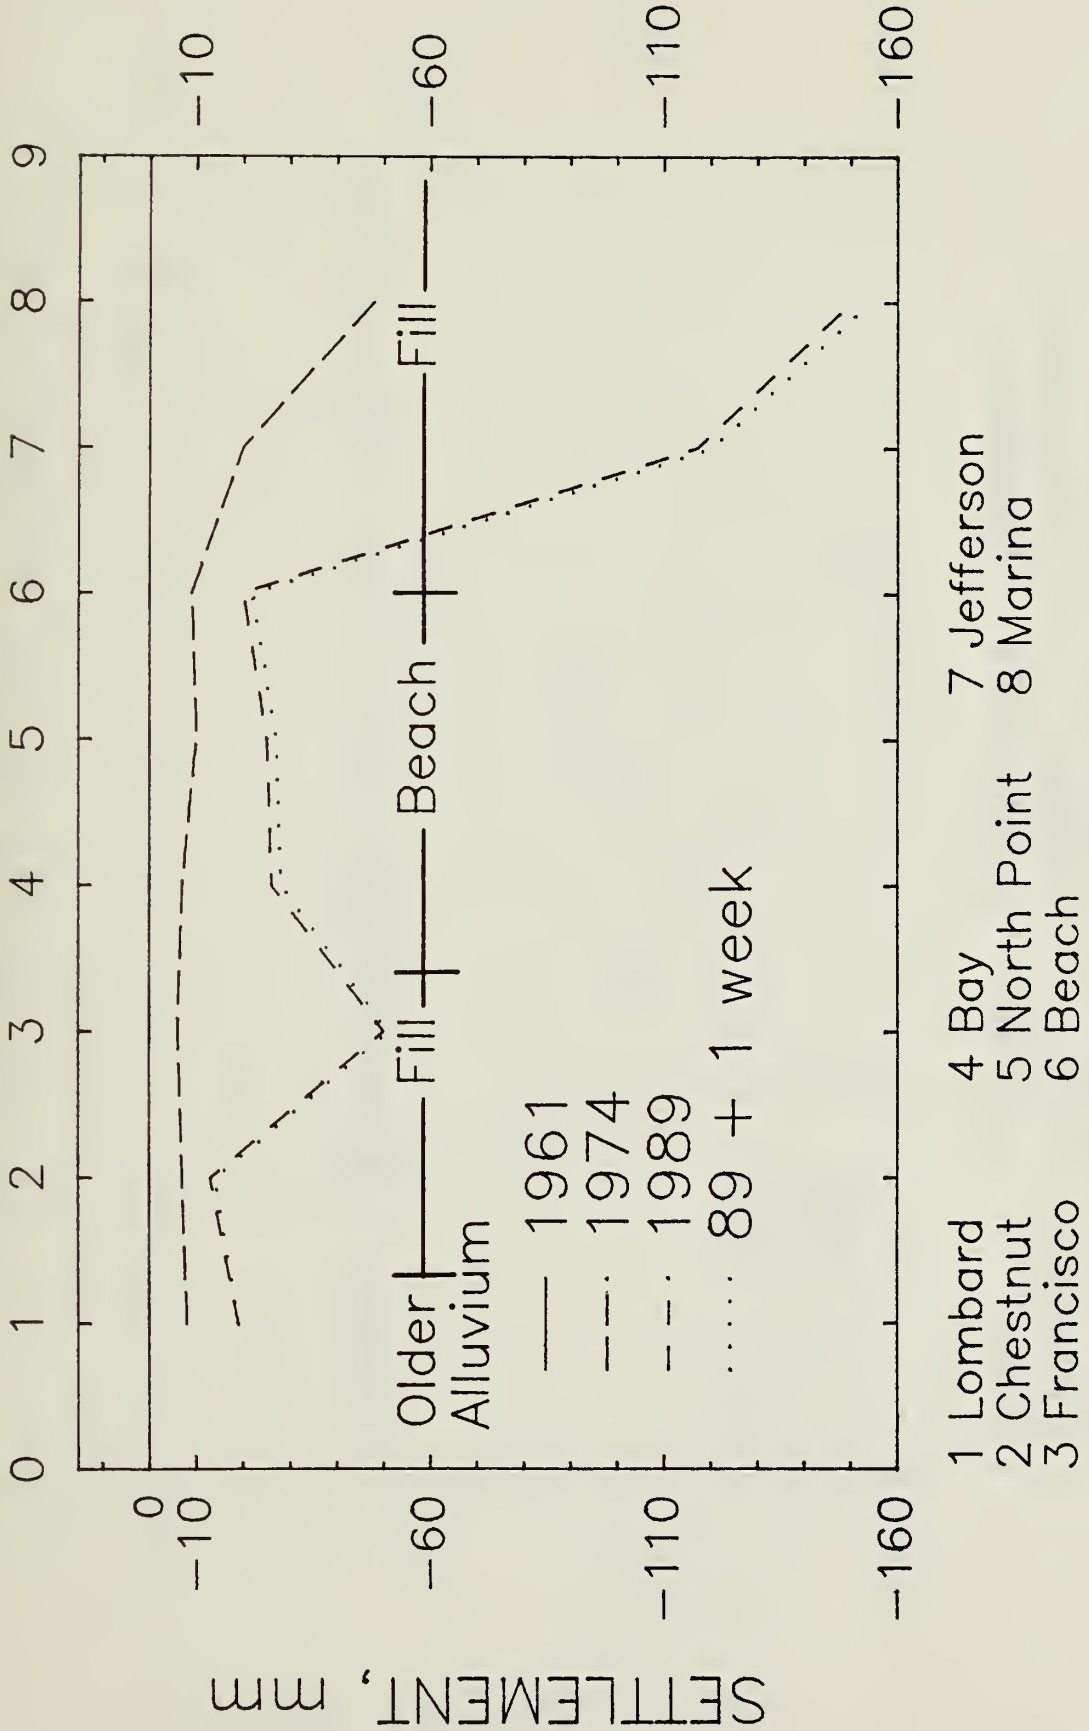
Figure 13. Settlement along Divisadero for three time intervals, 1961-1974, 1974-1989, and a one week period in November 1989.

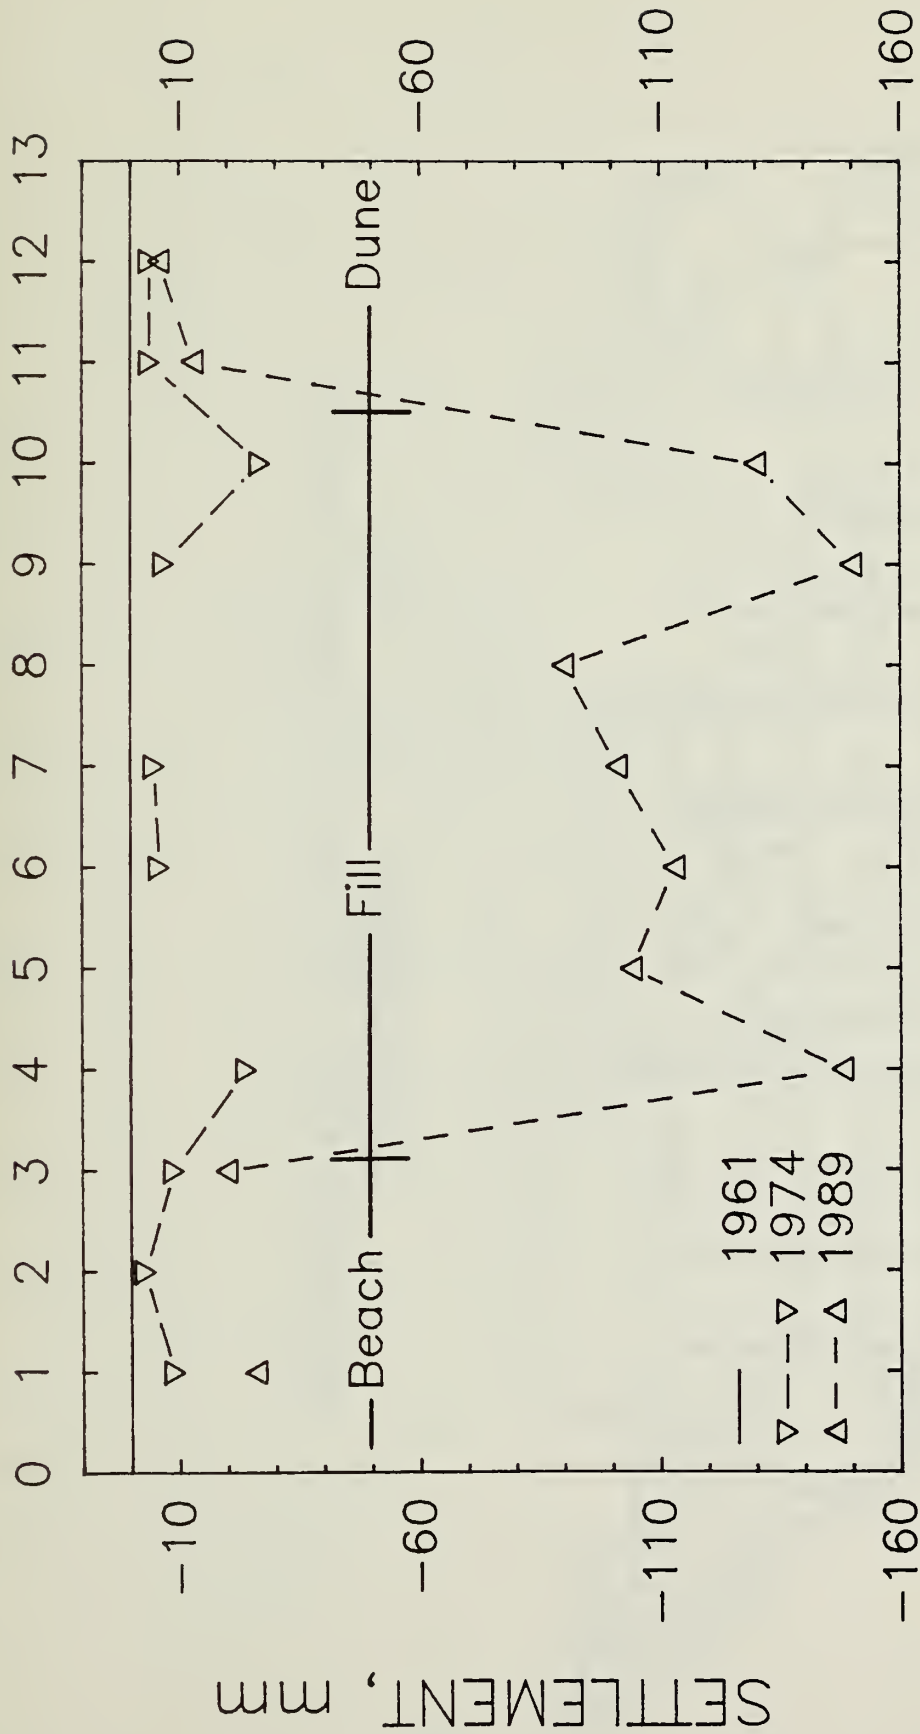
Figure 14. Settlement along Beach St. for the time intervals, 1961-1974, and 1974-1989. Avila and Retiro were not surveyed in 1961.

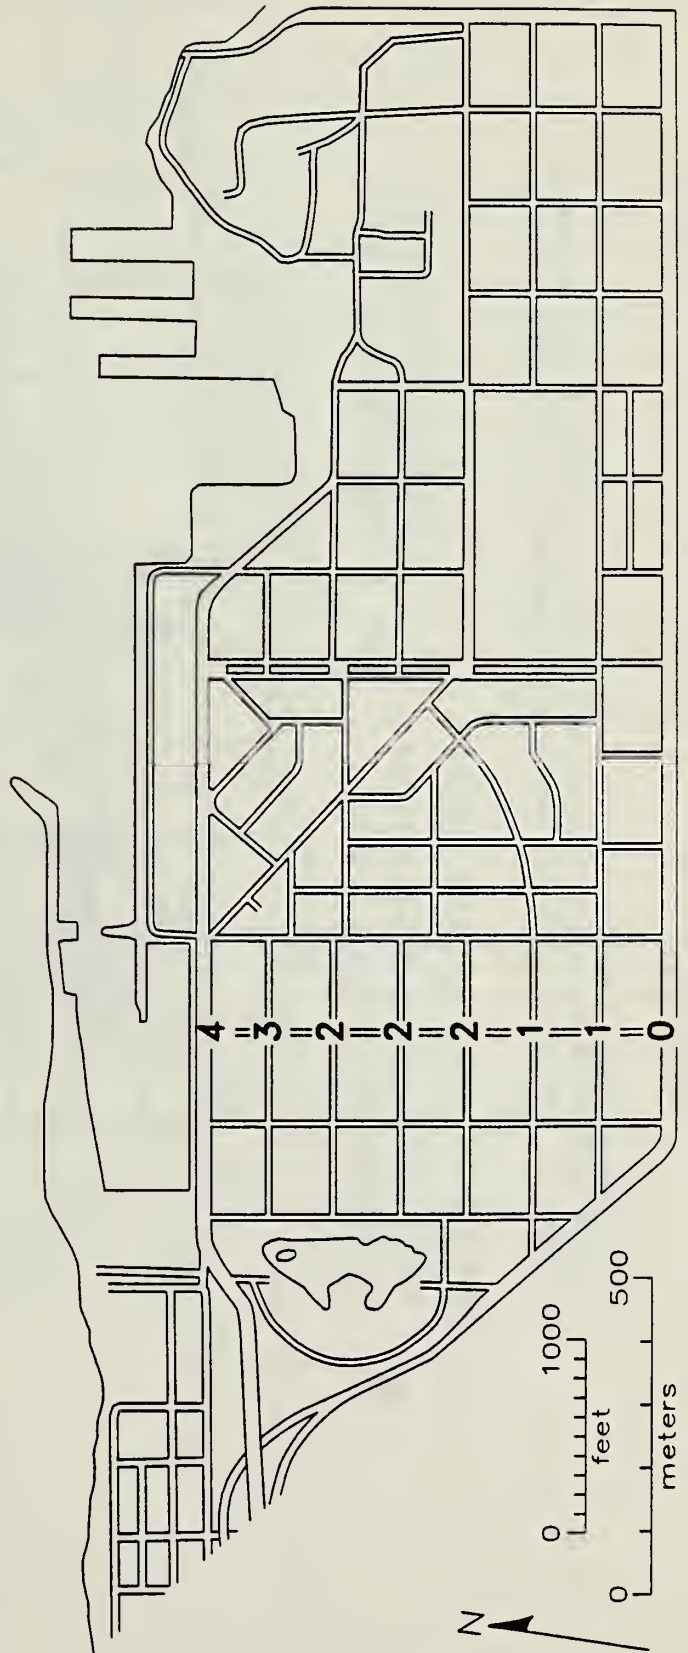
Two leveling surveys along Divisadero were made one week apart (November, 10-17). Holding the Lombard station as constant, settlement increases uniformly northward, at Marina Blvd the one week difference is 4 mm (fig. 15). Although the changes are small they are not random (written communication, A. Okamura, 1989).

Figure 15. Difference in elevation along Divisadero between November 10-17, 1989.

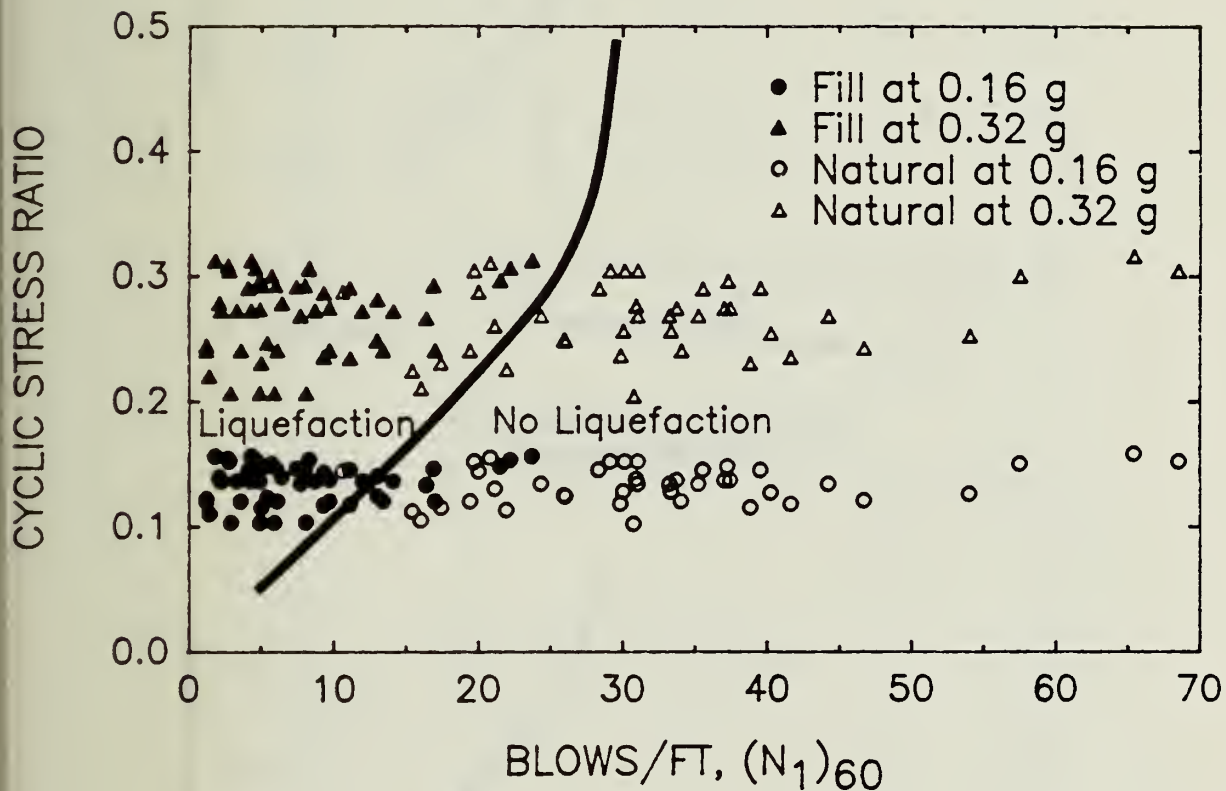
A liquefaction analysis of the fill and the natural deposits was conducted using SPT data collected by the USGS and also by Dames and Moore (Dames and Moore, 1976; Dames and Moore, 1977). The results of the analysis generally agree, data from the USGS and Dames and Moore are shown in figure 17, data from the USGS is shown in figure 18. The minimum acceleration, 0.16g, is sufficient to liquefy most of the fill, at 0.32 g all of the tests in the fill indicate liquefaction would occur. At the minimum acceleration, only 2 tests in the natural deposits indicate the sediment would liquefy, most of the tests indicate a high resistance to liquefaction. At the maximum acceleration, approximately 25 percent of the tests in the natural deposits indicate the soil has a low resistance to liquefaction.

Figure 17. Liquefaction resistance chart using data from Dames and Moore (1976 and 1977) and USGS (this report). The fill, mostly hydraulic fill from Marina Cove, has a very low resistance to liquefaction at accelerations between 0.16 and 0.32 g. The natural deposits have a high resistance to liquefaction at an acceleration of 0.16 g, at the higher acceleration of 0.32 g the liquefaction resistance of some of the natural deposits is low. The line represents the boundary between liquefaction and no liquefaction for a M 7.1 earthquake.

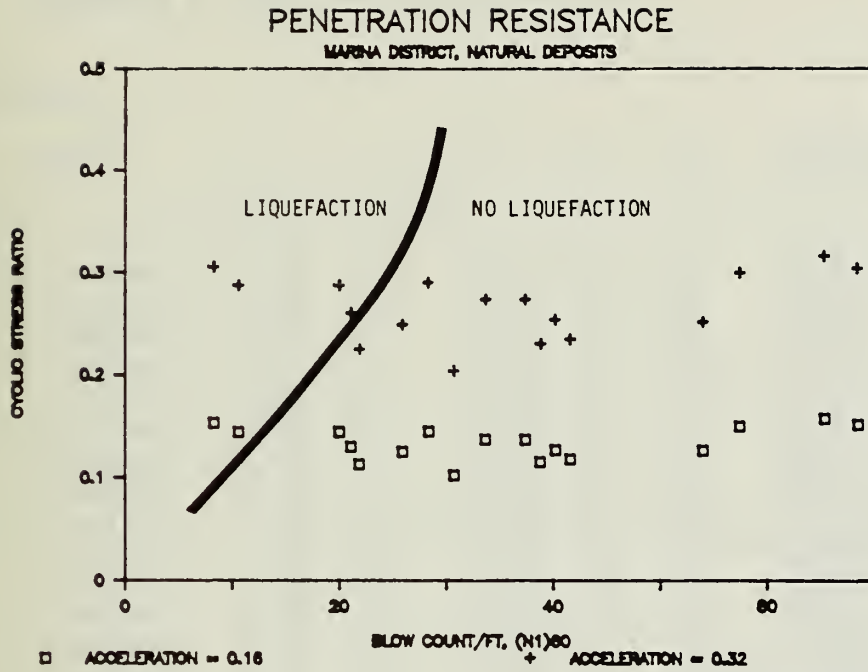
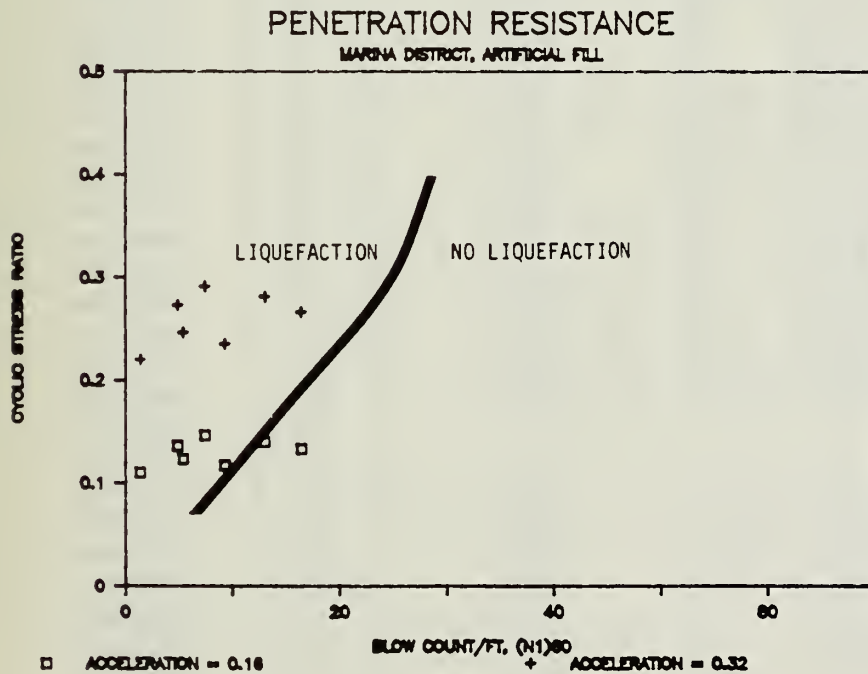
Figure 18. Liquefaction resistance chart using data from the USGS. This data confirms the Dames and Moore (1976 and 1977) data that show the fill has a very low resistance to liquefaction, whereas the natural deposits have a moderate to high resistance to liquefaction.
